***The Effect of Using Porcelain Mortar and Pestle in Sample Preparation for Scanning Electron Microscope-Energy Dispersive X-Ray (SEM-EDX) Analysis***

**Ida Ayu Sulistya**

*Integrated Laboratory, Directorate of Academic, Universitas Islam Indonesia*

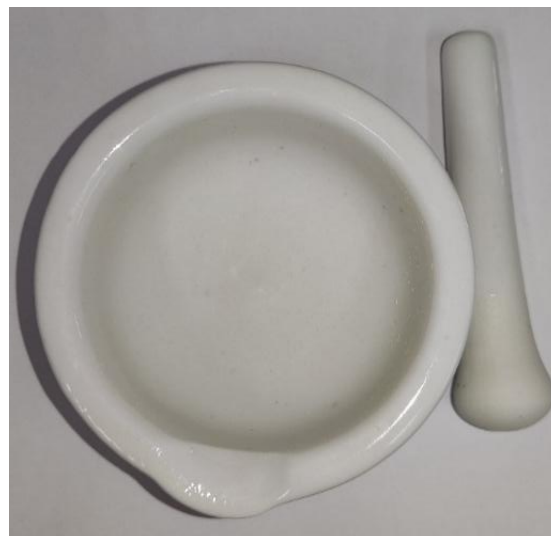
**.Figure 1.** New porcelain mortar used in this study.

Figure 1 shows a new porcelain mortar with no visible surface scratches.. In contrast, Figure 2 shows a used porcelain mortar exhibiting surface scratches caused by repeated use that cannot be removed by washing. These scratches are expected to accumulate progressively with repeated use. The elemental composition of the porcelain mortar may represent a potential source of contamination, that may be detected by EDX analysis.

This study generated surface morphology images and elemental composition data for samples prepared using three different preparation procedures, namely unground samples, samples ground using a new mortar and pestle (Figure 1), and samples ground using a worn mortar and pestle with extensive surface scratches (Figure 2). The elemental composition of the samples was determined by EDX analysis. This section focuses on the EDX results..
