# Livability Level As A Guideline Of Arrangement Of Suprpto Road City Walk Corridor In Bengkulu City

Rahzon Afryan<sup>1</sup>, M. Sani Roychansyah<sup>2</sup>

<sup>1</sup> Student of the Master of Architecture, Department of Architecture and Planning, Universitas Gajah Mada

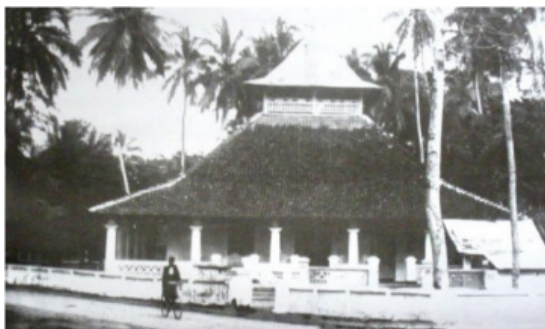
Figure 2. Suprpto Road located next to Jamik Mosque at the time before it was used as a trade and service area.  
Source: Google

The physical side of this road has been built with a wide road that can support trading activities, in the 2000s this road was improved in terms of the addition of sidewalks and road medians.

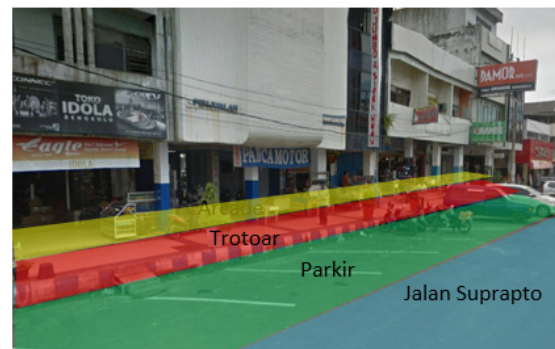
Figure 3. Pedestrian Path on Suprpto Street  
Source: Personal Documents

On this road there are arcades and sidewalks as pedestrian paths for the people of Bengkulu to walk in this area. this street has parking on street along the road. But at that time Bengkulu people still often used public transportation to travel to Suprpto Street. Therefore, the vehicle parking lot was used by street vendors to sell their products. Activities in the walking path are still very comfortable and safe to pass by visitors

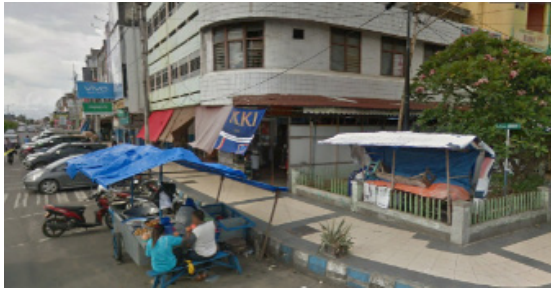
Figure 4. The condition of activities on the sidewalks of Suprpto Street after being revitalized by the Bengkulu city government still looks empty of users.

As the city of Bengkulu developed in 2009 the Bengkulu government established a new modern shopping center, Mega Mall and Bengkulu Indah Mall. This is enough to affect the Suprpto area because many residents find it more attractive to shop at the new shopping center that provides more comfortable needs and places of escape. in addition, Suprpto Road experienced a decrease in activity due to the considerable increase in traffic flow experienced by Bengkulu Province, due to the increasing number of motor vehicle growths of  $\pm 15.04\%$  per year (Anzy and Legowo, 2016). Decreased activity in this road space which causes street vendors who used to sell at vehicle parking locations can no longer do so. The curbing carried out by the Bengkulu city government resulted in the removal of street vendors. In response to this in 2015 the Bengkulu government revitalized the sidewalks and drainage canals on this road aimed at

providing comfort for pedestrians and street vendors. However, these efforts have not yet to produce these results as seen from the still low usage of the sidewalk.

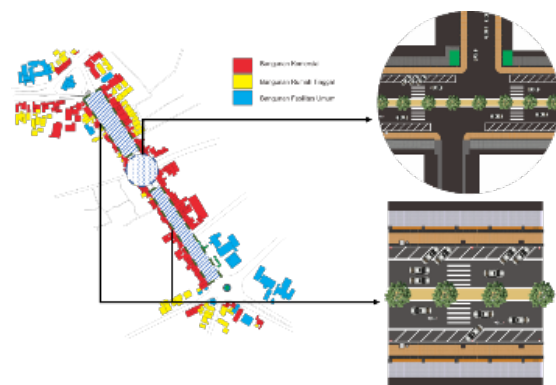
Figure 6. Pedestrian Line on Suprpto Street.  
 Source: Researcher Analysis 2019

2. Have Pedestrian Trails Along the Corridor  
 Based on the results of surveys and field observations that Suprpto street has a pedestrian path, but there are some parts that are still cut off. Some parts along

Suprpto street pedestrian path are also heavily functioned by the sidewalk seller and shopkeepers to put their wares. This makes the pedestrian lane experience the transfer carried out by street vendors and shop owners, making it inconvenience for the pedestrian lane users on Suprpto street.

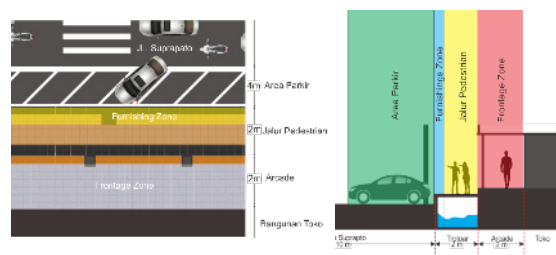
Figure 7. Pedestrian Line Zone that exists today  
 Source: Researcher Analysis 2019

Based on the results of surveys and observations, the road already has a pedestrian zone consisting of 4 zones including Crub Zone, Furnishings Zone, Trough Zone, and Frontage Zone. This has fulfilled the criteria needed in implementing the City Walk Concept. The following is the Pedestrian Zone that already exists on Suprpto Street:

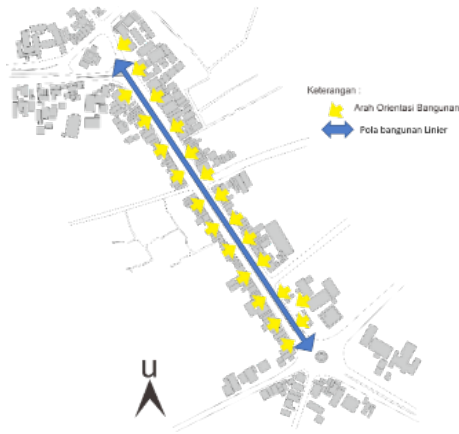
Figure 9. Condition of building orientation on Suprpto Street  
Source: Researcher Analysis 2019

3. Building Pattern  
 Based on the results of surveys and field measurements, the building pattern is oriented towards facing the road and has

a linear building pattern, following the orientation of the building and the linear building pattern that exists on Suprpto Street.
